Spot Safety Project Evaluation

Spot Safety Project # 07-00-200

Spot Safety Project Evaluation of the Realignment of SR 1136 (Bellemont Rd-Alamance Rd) and Its Intersection with NC 62. Also Includes Installation of Left Turn Lanes on NC 62 for Its Intersections With SR 1136 and SR 1130 (Friendship-Patterson Mill Rd)

Alamance County

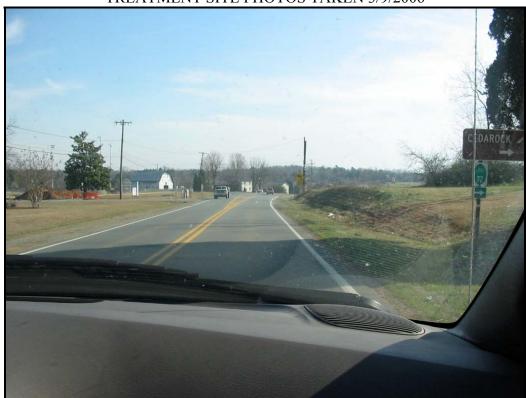
Traveling North on NC 62 – Start of Taper

Please see the attached *Treatment Site Photos*. Photos are proved for all approaches to the intersection, as well as site distances from both SR 1130 and SR 1136.

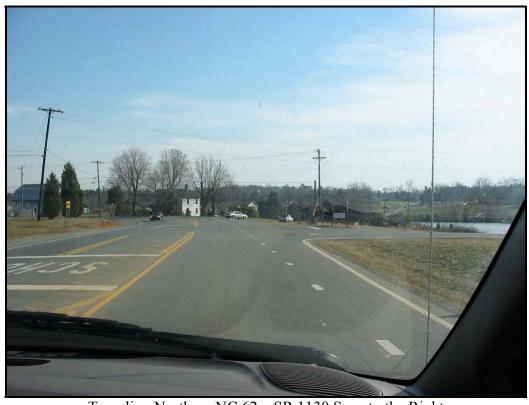
Traveling North on NC 62 – SR 1130 Seen to the Right

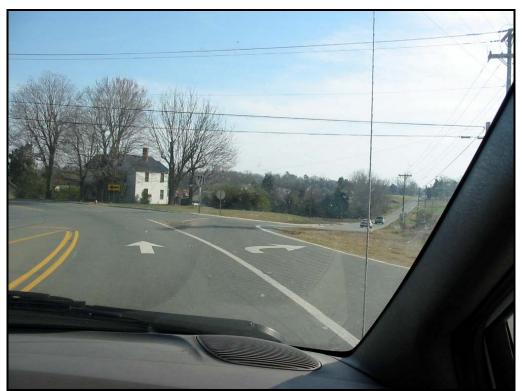
Traveling North on NC 62 – SR 1136 Seen to the Right

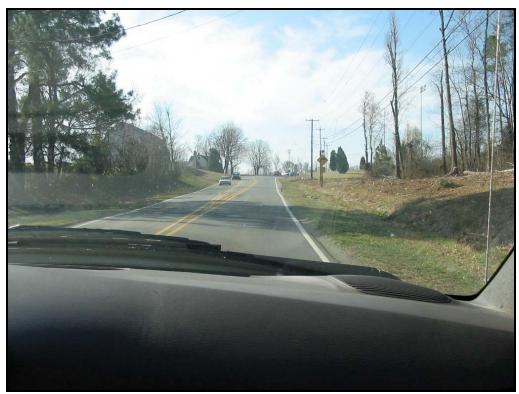
Traveling South on NC 62 – Start of Taper

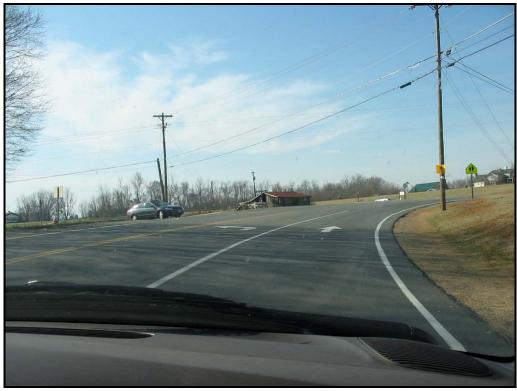
Traveling South on NC 62 – SR 1136 Seen to the Left

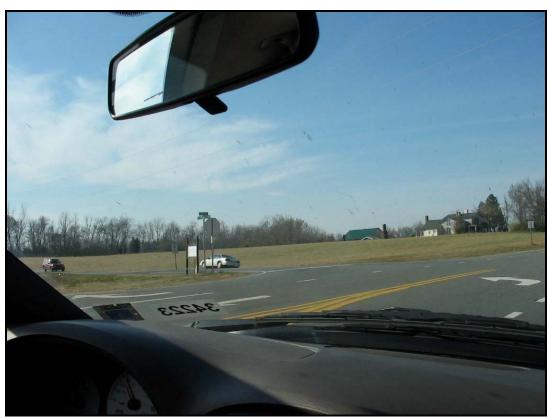
Traveling South on NC 62 – SR 1130 Seen to the Left

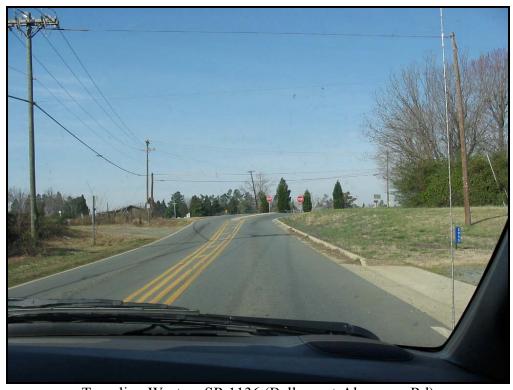
Traveling West on SR 1136 (Bellemont-Alamance Rd)

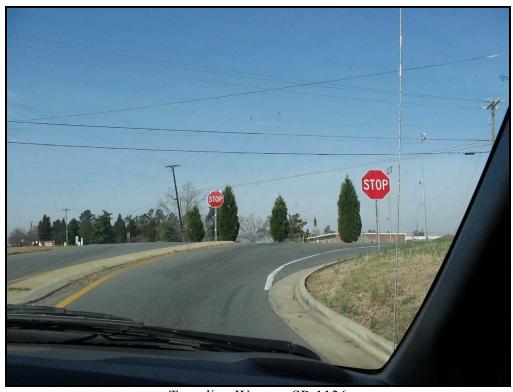
Traveling West on SR 1136

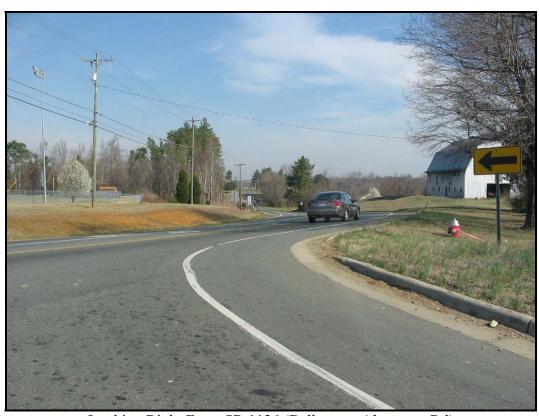
Looking Right From SR 1136 (Bellemont-Alamance Rd)

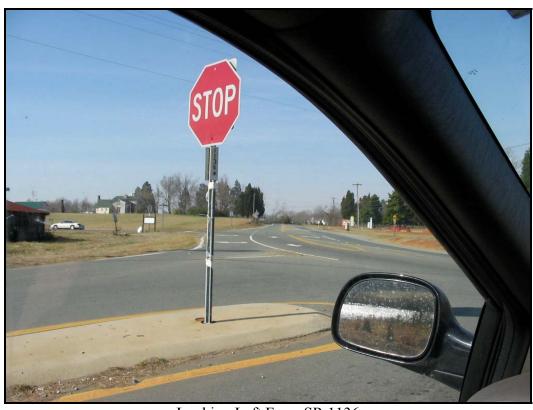
Looking Left From SR 1136

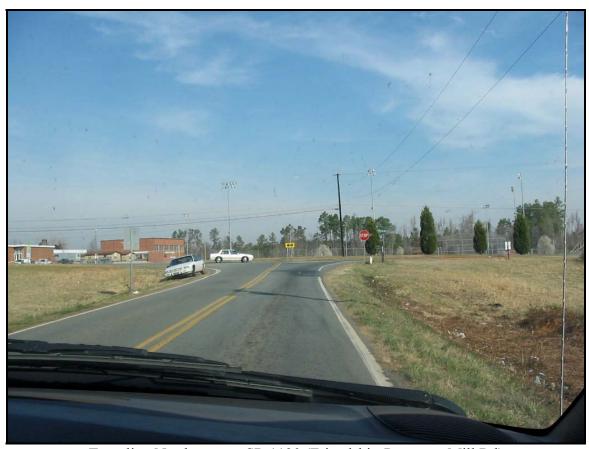
Traveling Northwest on SR 1130 (Friendship-Patterson Mill Rd)

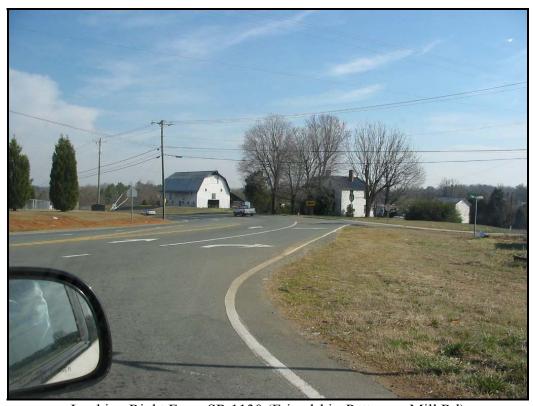
Looking Right From SR 1130 (Friendship-Patterson Mill Rd)

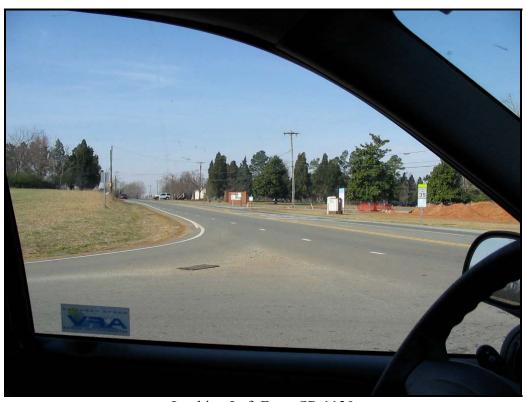
Looking Left From SR 1130

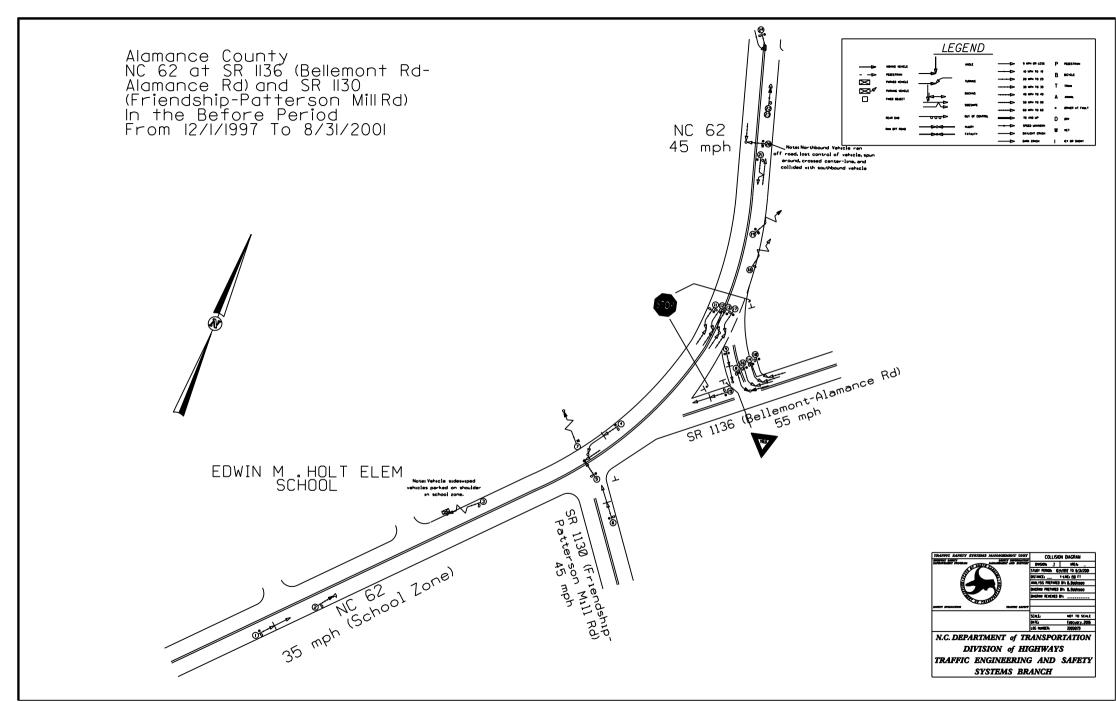
Referencing the *Collision Diagram, Before Period* there appears to have been an existing pattern of crashes between the two legs of SR 1136 at the intersection. The realignment of the intersection eliminated this movement, therefore eliminating the pattern of crashes.

The spot safety project improvement countermeasures chosen for the subject location was the installation of left turn lanes on NC 62 and the realignment of SR 1136 to "tee" into the center of the curve on NC 62. NC 62 is a 2-lane facility with a speed limit of 45 mph for the southern approach and a speed limit of 35 mph for the northern approach due to a school zone. SR 1130 is a 2-lane facility with a speed limit of 45 and no turn lanes. SR 1136 is a 2-lane facility with a speed limit of 45 mph. Before the project, SR 1136 had a concrete median splitting it into two legs allowing easier access to NC 62. Please see *Collision Diagram, Before Period* for more detail.
